# **Taber Abrasion Flooring Comparison**

A Taber Abrader was used to compare a series of flooring samples against the **PRECIDIUM™ MTI Floor System**. Testing was done under 1000g load for 1000 cycles, with wheels resurfaced every 500 cycles. Each floor sample was tested with a CS-17 and H-18 abrasive wheel, common test wheels. The CS-17 is a mild-medium abrasive while the H-18 is a medium-coarse abrasive, and accordingly results in a great deal more abrasion.

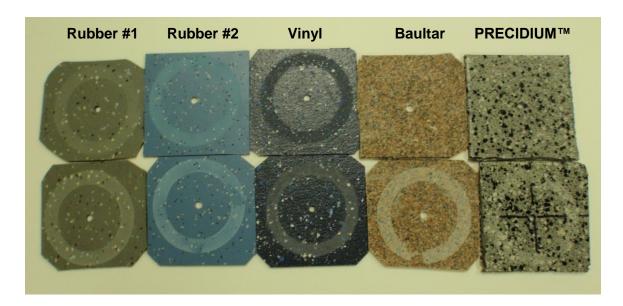
Below is a picture of the samples following testing. The top row of samples were tested with the CS-17 wheel while the bottom row was tested with the H-18 wheel. \*It is important to note that the H-18 **PRECIDIUM™** sample was subjected to 1500 cycles while the others were only tested to 1000 cycles. This was done for interest as it wore down to the accent colors, and the sample lost 110mg during the additional 500 cycles.

Material	CS-17 Weight	CS-17	H-18 Weight	H-18 Thickness
	Loss	Thickness Lost	Loss	Lost
	(mg)	(mil)	(mg)	(mil)
Vinyl	50	0.6	340	4.1
Rubber #1	160	1.8	620	7.1
Rubber #2	120	1.1	580	5.4
Baultar	120	0.9	620	4.4
PRECIDIUM™	60	0.8	180	2.4

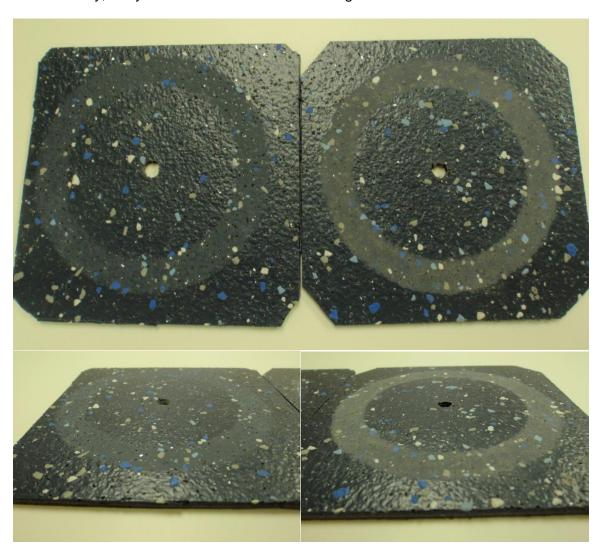
## Vinyl

Vinyl had the best numerical results for CS-17 wheel, and second best for the H-18 wheel. It was not, however, the best in appearance. The gloss change was almost immediate, and the abrasion uncovered small pits that seemed to indicate that the vinyl was somewhat porous, which means dirt pickup would be high and cleanability low, as it gets worn down. The H-18 sample's color was quite evidently changed and seemed almost chalky, likely due to dust from abrasion being held on the surface.

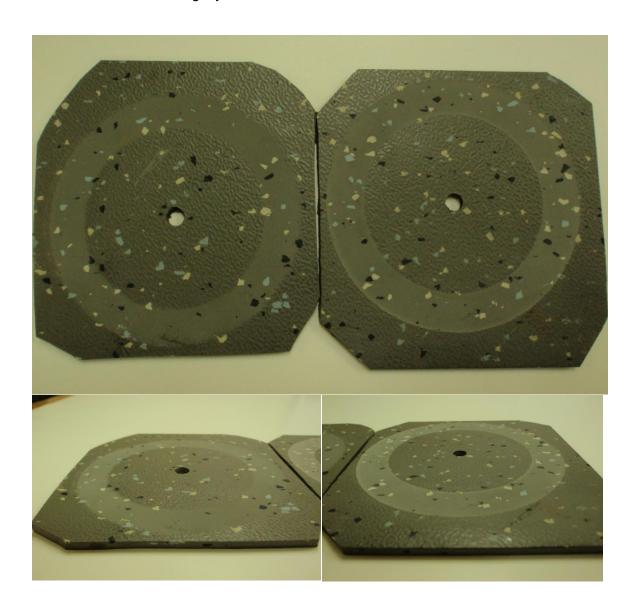
## Rubber Sample #1

Rubber Sample #1 performed better than Rubber Sample #2, with lower weight loss but significantly lower thickness loss due to being a higher density. Being a darker color, the wear tracks were also slightly less noticeable.

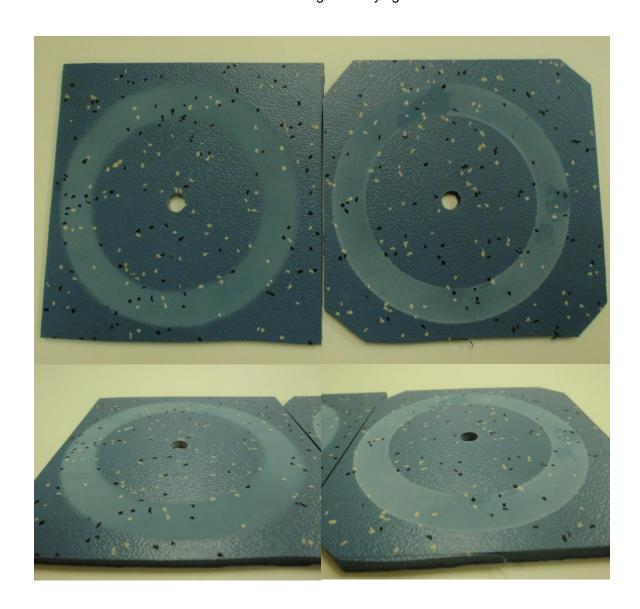
## **Rubber Sample #2**

Rubber Sample #2 performed the worst for both weight and thickness lost for both the CS-17 and H-18 wheels. Wear tracks are significantly lighter in color.

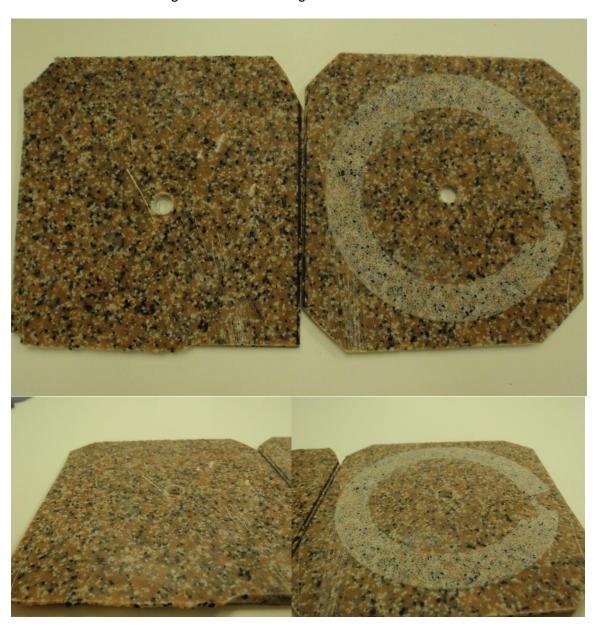
### **Baultar**

Baultar is the odd flooring of this testing group. Where the others are flexible, the Baultar is quartz contained in a solid matrix that is extremely rigid. The CS-17 wheel made a slight wear mark that is noticeable as being slightly glossier. It did lose the second most weight but that did not translate into much thickness loss as the density is quite high. For the H-18 wheel the change in abrasiveness created a much different result as the Baultar lost the most weight and the wheels ground into the matrix.

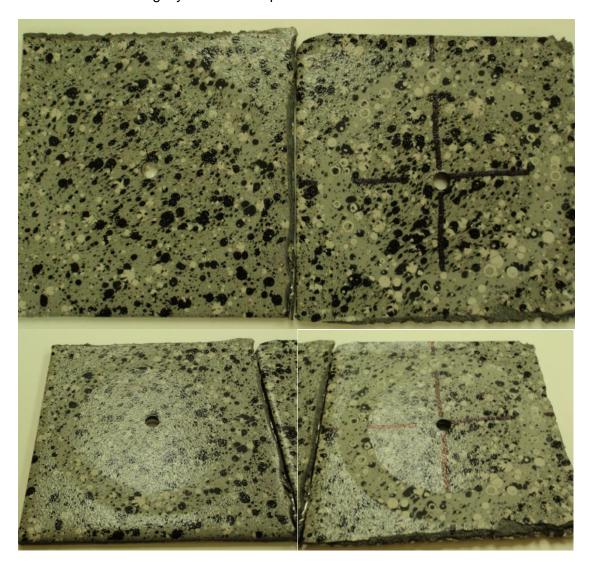
#### **PRECIDIUM™**

PRECIDIUM™ had the second best results for the CS-17 wheel, coming in close behind the vinyl. For the H-18 wheel it had significantly superior properties, losing just over half as much weight as the vinyl and under a third of the weight of the other samples. It also had significantly less thickness loss. The wear tracks from the CS-17 wheel showed no perceptible color change, but a drop in gloss is evident, especially as these were the glossiest samples at the start. The wear tracks for the H-18 wheel are pictured after 1500 cycles; after 1000 cycles the accent colors had not yet been reached, but unfortunately no pictures were taken before the additional 500 cycles were run. An advantage to note is that at this point the PRECIDIUM™ could be refinished with a new top coat that would restore it to its original condition, even in a different color combination if flooring style was revamped.
