Adhesion of PRECIDIUTM Rail Floor to Phenolic Composite Panels

A request was made for adhesion data for the **PRECIDIUM™ Rail Floor System** on phenolic composite panels.

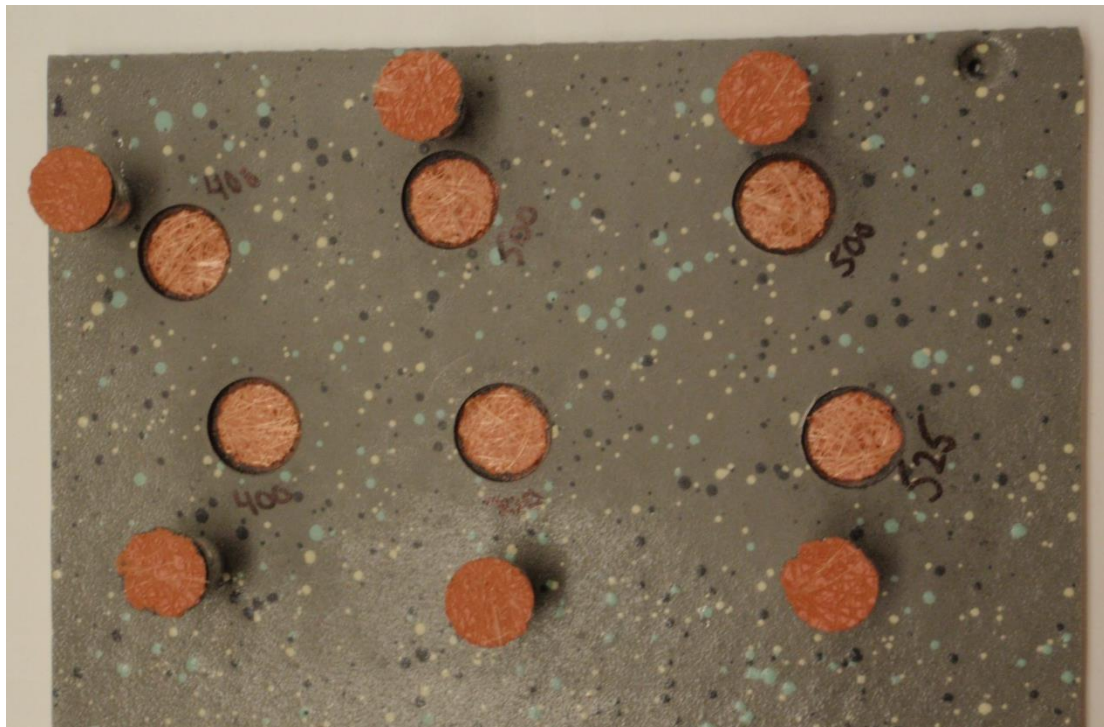
Below: Panel 'B' after testing

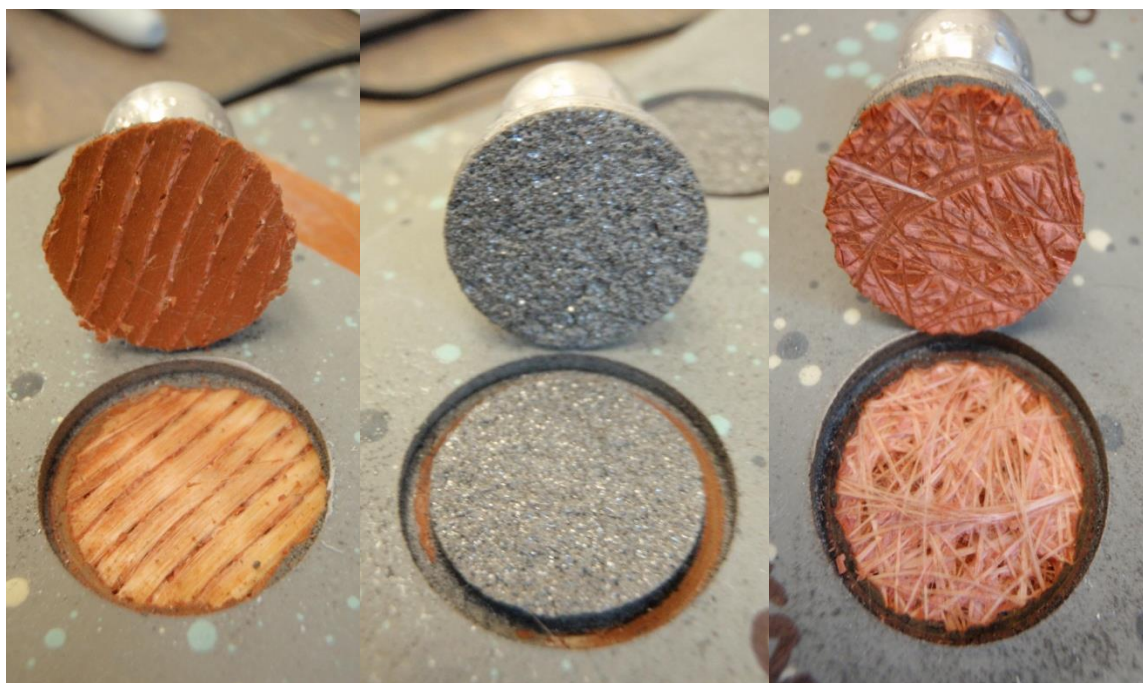
Above left to right: Panel failure on A, membrane failure on A, panel failure on B

The results show excellent adhesion to both of the panels, but also illustrate the difference between types of phenolic panels. Panel B had an average of 504 psi, just over half of Panel A's 925 psi, but this can be misleading as every failure for Panel B was the panel itself. The close-up picture shows the panel surface being pulled cleanly off of the random fiberglass structure beneath it. Panel A only had one panel failure, with the rest coming from the membrane exceeding its tensile strength, indicating the panel was much more resilient. It is evident from this that the structure and type of phenolic panel will play a large role in the adhesion numbers obtained.
